**Subject: Pavement Evaluation Report  
PPLD Library 21c  
1175 Chapel Hills Drive  
Colorado Springs, Colorado 80920**

**PAVEMENT EVALUATION  
PPLD LIBRARY 21c  
1175 CHAPEL HILLS DRIVE  
COLORADO SPRINGS, COLORADO 80920  
KLF PROJECT 20164613.001A**

**August 10, 2016**

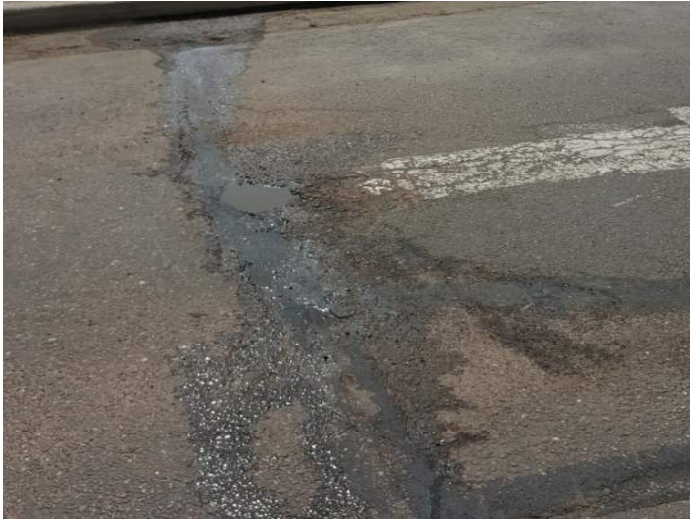
**Photograph 1:** Moderate- to high-severity cracking and ponding in main entrance, looking south

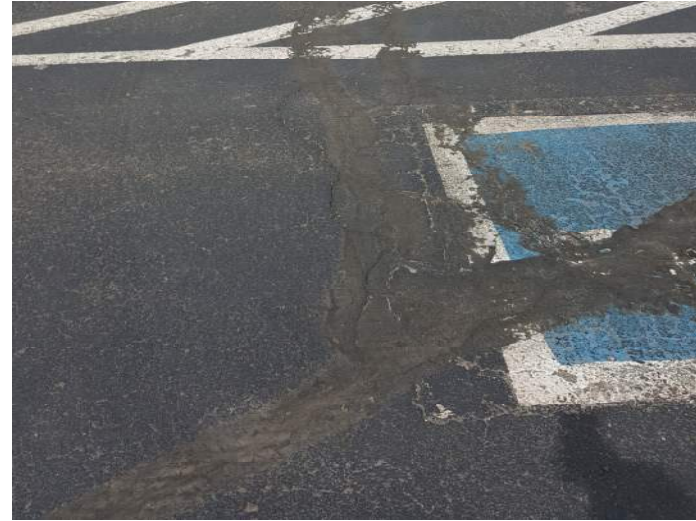
**Photograph 2:** Partially sealed moderate-severity fatigue cracking, main entrance ADA parking, looking west.

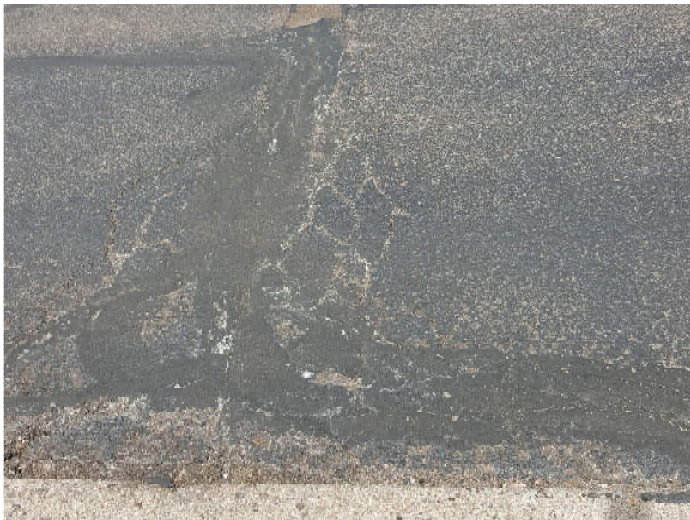
**Photograph 3:** Low- to moderate-severity fatigue cracking, NE entrance (Area No. 3), looking north.

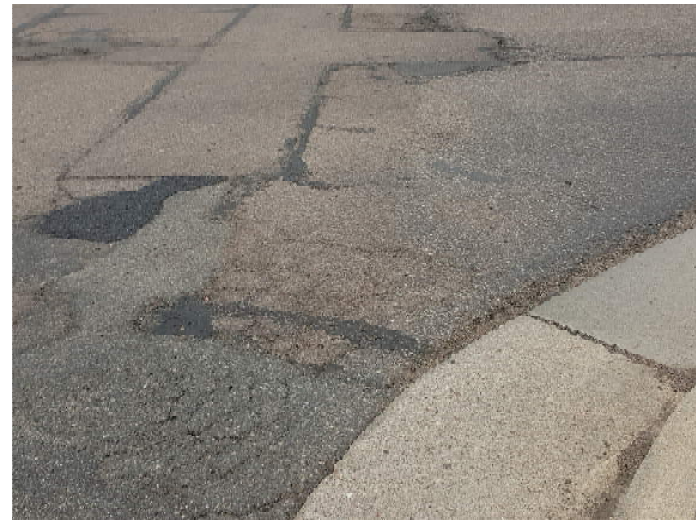
**Photograph 4:** Low-severity fatigue and joint cracking around patches, SW entrance area (Area No. 2), looking north.

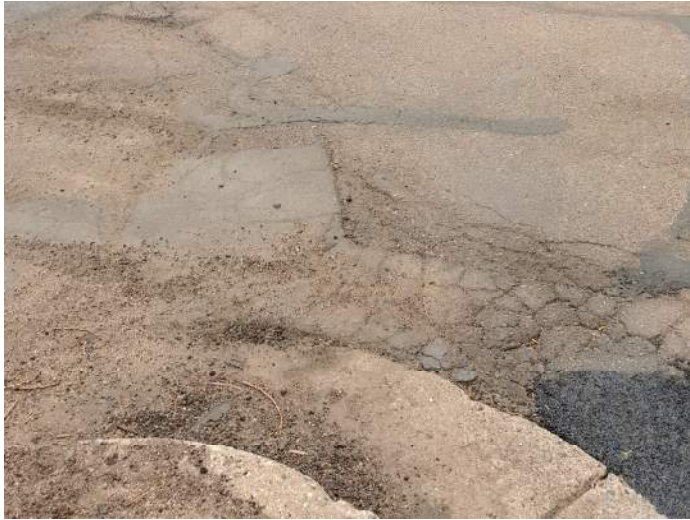
**Photograph 5:** Low- to moderate-severity fatigue cracking, and patches, loading dock, looking southwest.

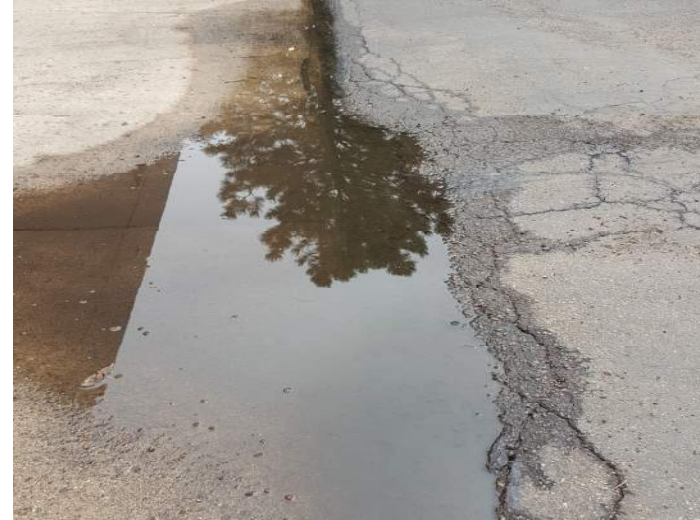
**Photograph 6:** high-severity edge cracking, fatigue cracking, settlement and ponding, loading dock, looking south.

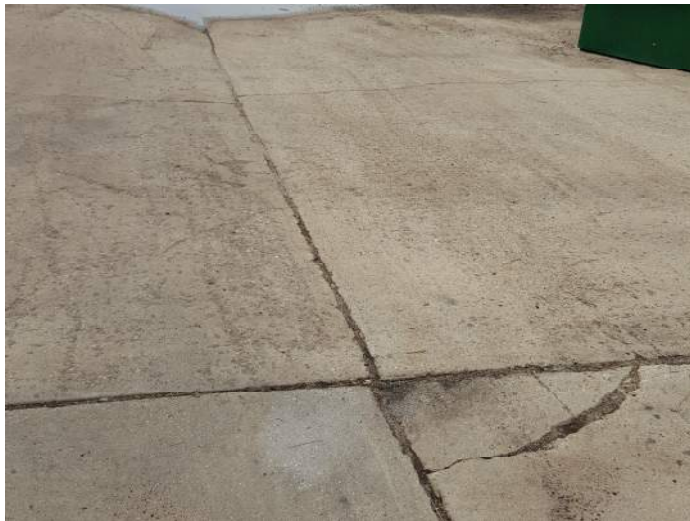
**Photograph 7:** Isolated low-severity scaling, low-severity corner break, loading dock, looking west.

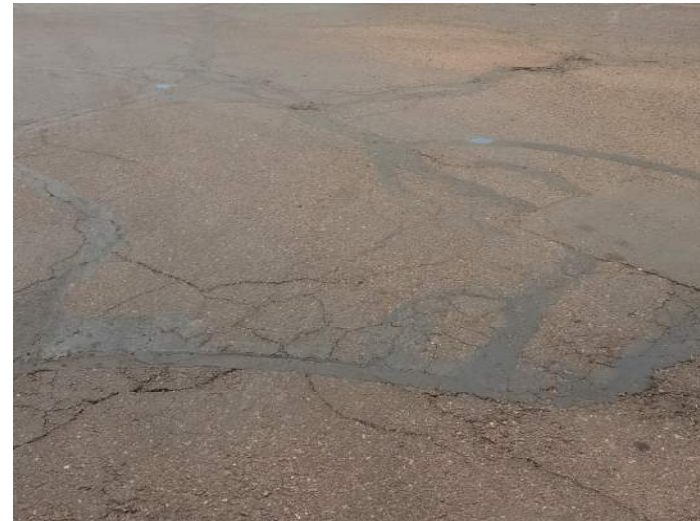
**Photograph 8:** low-severity fatigue cracking, low-severity raveling, loading dock area, looking south.

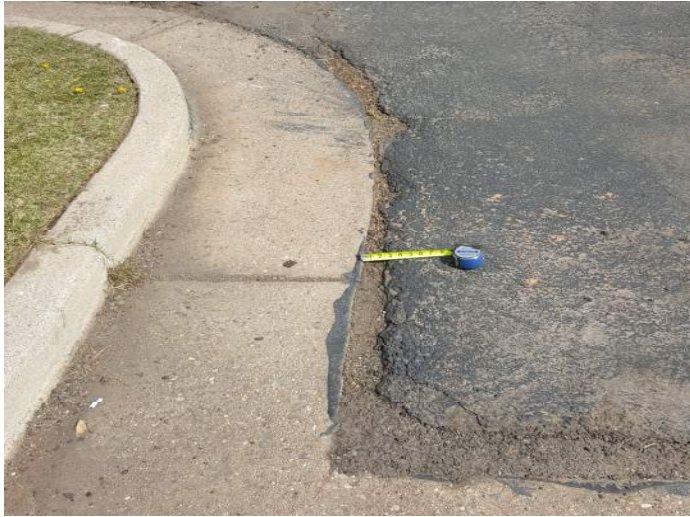
**Photograph 9:** High-severity edge cracks, low severity raveling southeast parking area, looking north.

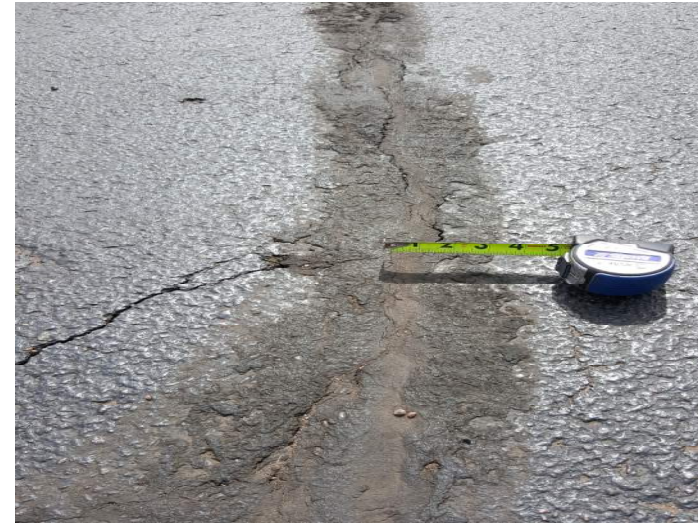
**Photograph 10:** Sealed high-severity transverse cracking, southeast parking area, looking east.

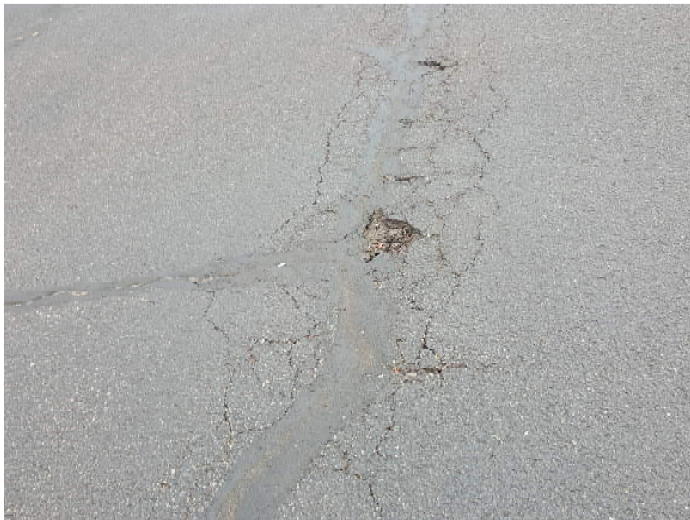
**Photograph 11:** low-severity fatigue cracking, isolated pot holes, and rutting, northeast parking area, looking north.

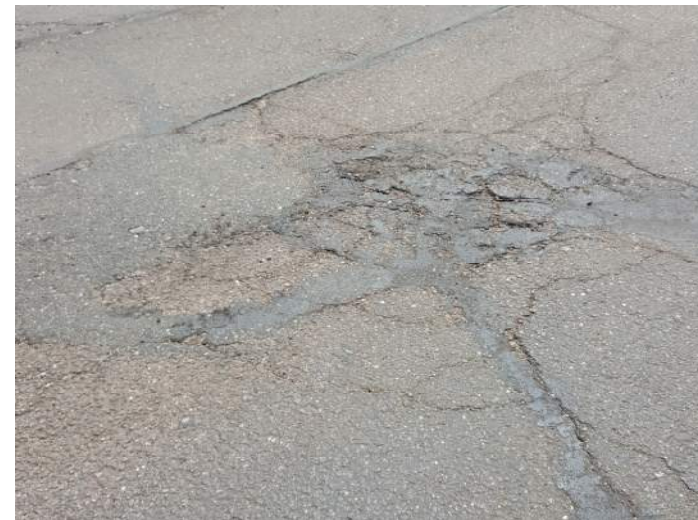
**Photograph 12:** Low- to medium-severity fatigue cracking, partially sealed, northeast parking area, looking east.

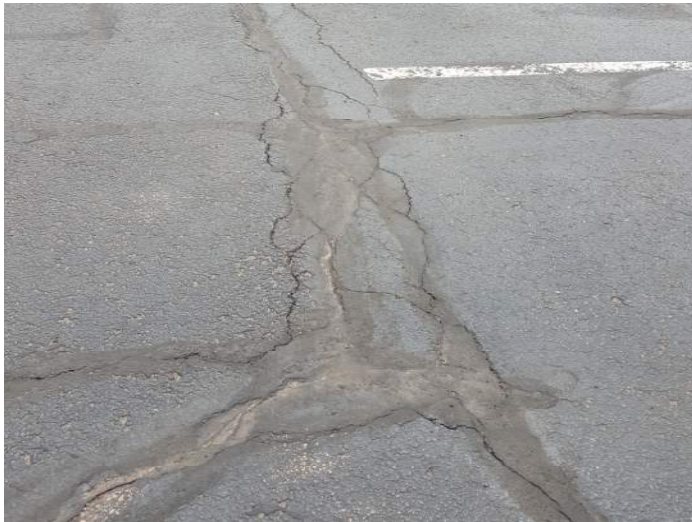
**Photograph 13:** Low-severity fatigue cracking, partially sealed, lower (west) parking area, looking south.

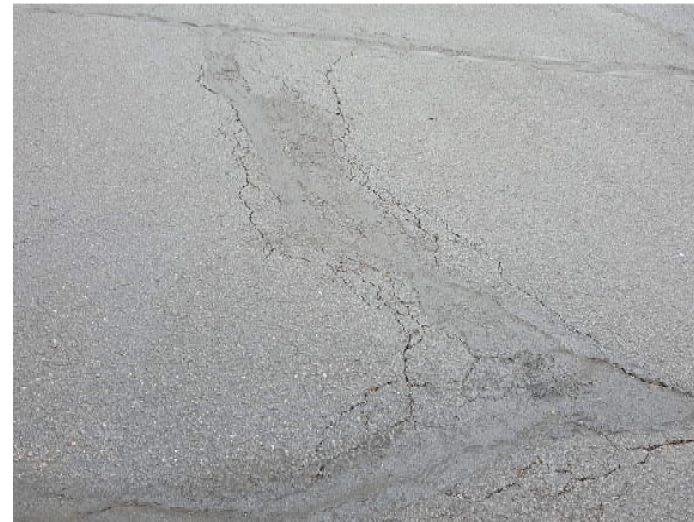
**Photograph 14:** Low-severity fatigue cracking, partially sealed, lower (west) parking area, looking south.

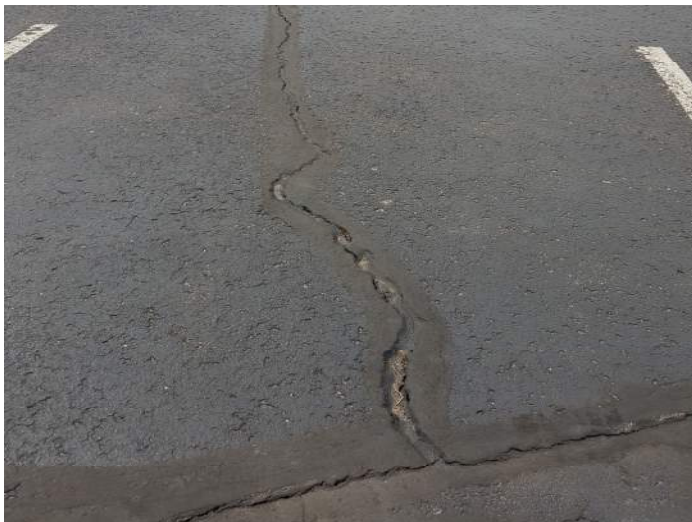
**Photograph 15:** sealed high-severity longitudinal and transverse cracking, south parking area, looking west.

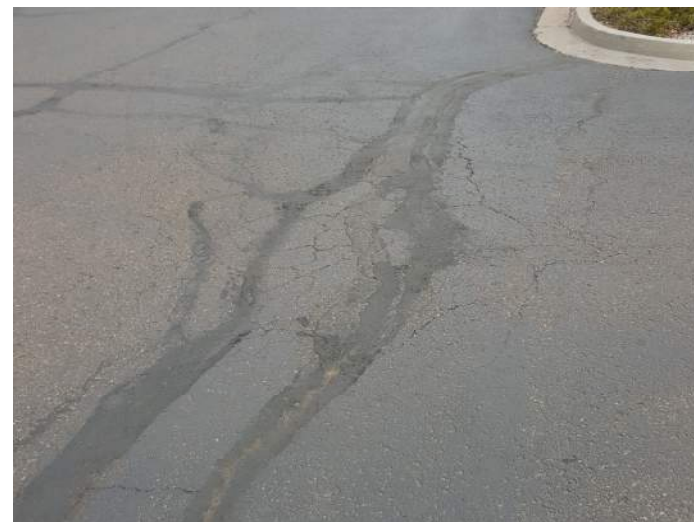
**Photograph 16:** Low-severity fatigue cracking, low- to moderate severity rutting, south parking area/drive lane, looking east.
