PIKES
PEAK
LIBRARY
DISTRICT
FACILITIES MASTER PLAN

FINAL SUBMITTAL | 10.2024

HB&A-ReThinking Libraries-Farnsworth Group

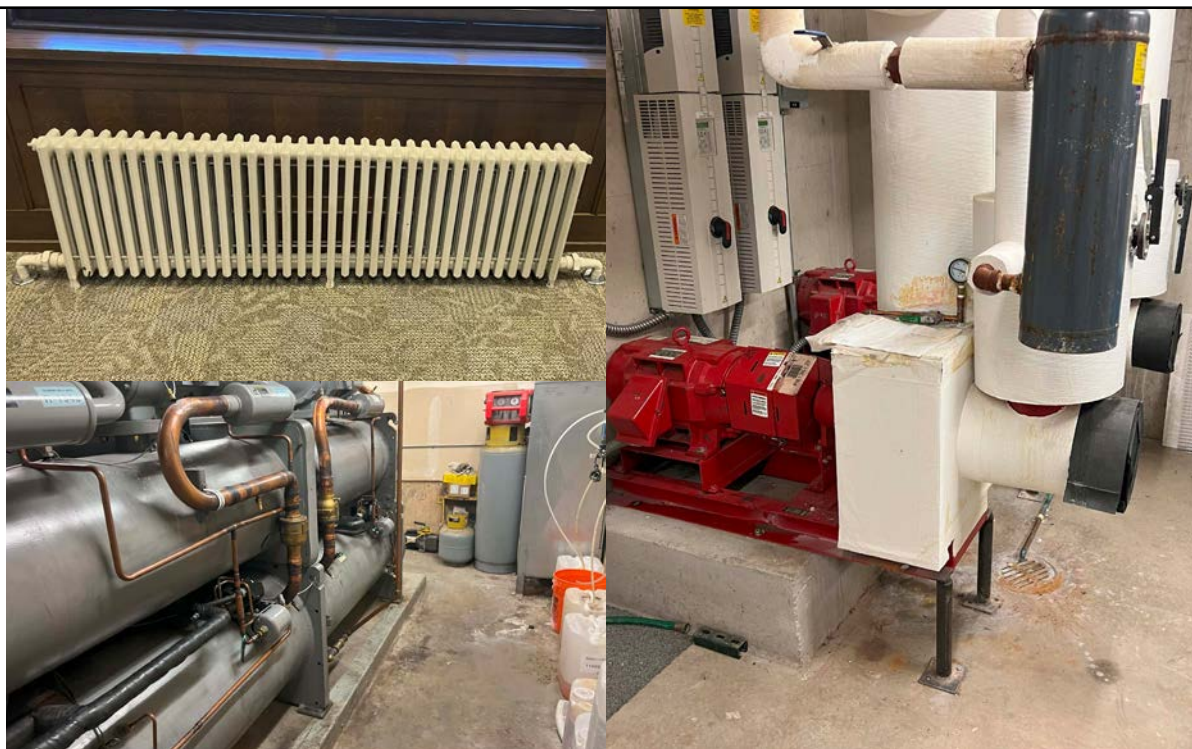
Clockwise from top left: Farnsworth Group completed field assessments for all district branches, determining facility deficiencies and recommended pathways forward for PPLD. Some of the deficiencies include HVAC air and water systems, as pictured to the right.

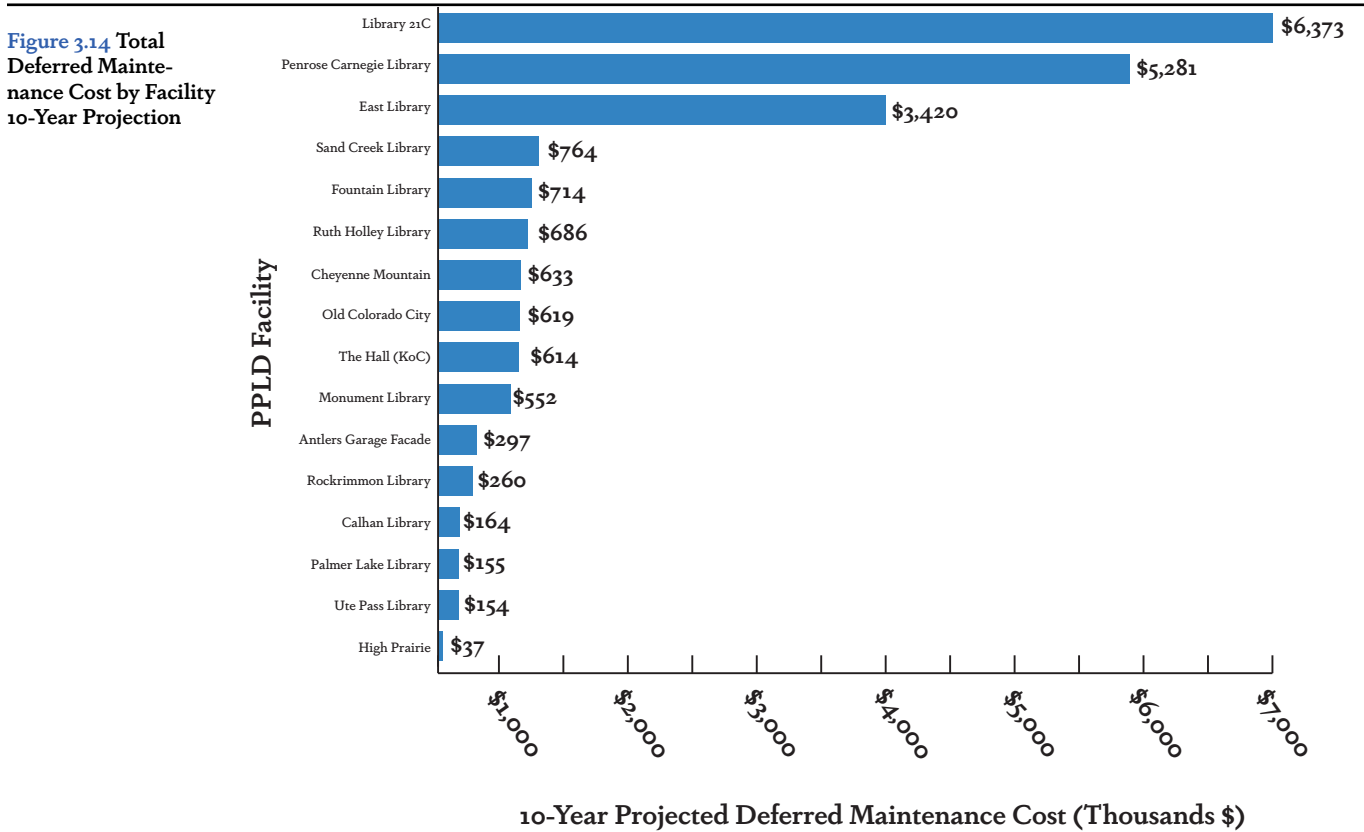
Figure 3.15 shows the 10-year forecast of deferred maintenance by facility. The larger owned facilities, 21C, East, and Penrose/Carnegie account for ~\$15M (72%) of the total deferred maintenance (\$20.7M) over the next 10 years. The smaller and leased facilities account for ~\$5.7M (28%) of the total deferred maintenance.

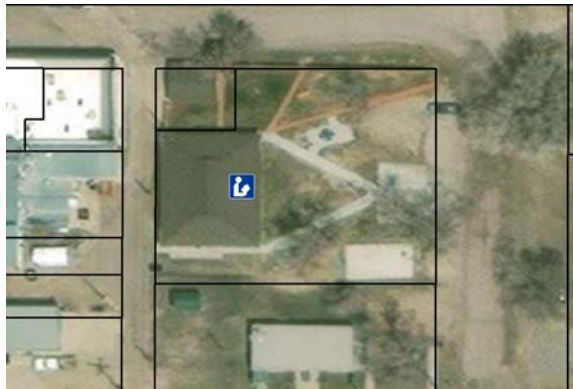
Calhan Library originally opened in 1977 but closed in 1982. It was reopened in 2019 in a pre-existing, 2,400-square-foot facility built in 2006, which is owned by the Pikes Peak Library District.

<p>Key Programmatic Issues</p>	<ul style="list-style-type: none"> • Children and teen programming • Inconvenient hours • Staffing deficiency/weather closures
<p>Key Condition Issues</p>	<ol style="list-style-type: none"> 1. Lifecycle: <ul style="list-style-type: none"> • Electrical: fire alarm, alarm, internet renewal • Roof coverings and openings Renewal 2. Deficiency: <ul style="list-style-type: none"> • Investigate/repair foundation • Repair and repaint damaged ceiling • Repair roofing - ridge cap • Repair/eliminate water infiltration • Replace unit heaters 3. Codes and Standards <ul style="list-style-type: none"> • Provide fire protection

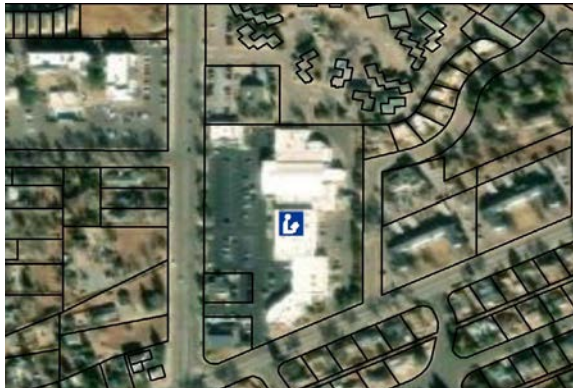
The Cheyenne Mountain Library was opened in 1993, replacing the Broadmarket Square Library. The library is housed in a 8,900-square-foot facility that was built in 1985 and is leased to Pikes Peak Library District.

Key Programmatic Issues	<ul style="list-style-type: none"> • Inconsistent hours of operation • Desire for Wednesday hours • Desire for maker spaces • Book selection • Facility size
Key Condition Issues	<p>1. Deficiency:</p> <ul style="list-style-type: none"> • Book drop openings are leaking • Corroding exterior windows • Exterior door seals • Rusted stub out

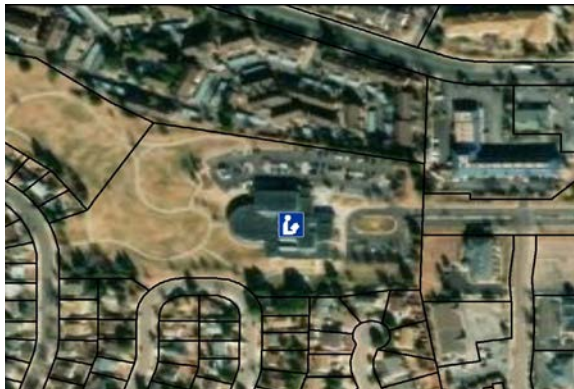
The East Library was opened in 1987. The library is housed in a 70,153-square-foot facility that was built in 1986 and is owned by Pikes Peak Library District.

Key Programmatic Issues	<ul style="list-style-type: none"> • Improve layout and staff spaces • Enhance bookshelf display/service points • Meeting room scheduling/dividers • Reconfigure adolescent/teen spaces • Provide quiet, spacious seating/study areas • Add outdoor furniture • Address parking lot insufficiency • Expand/upgrade sorting system
Key Condition Issues	<ol style="list-style-type: none"> 1. Safety <ul style="list-style-type: none"> • Electrical maintenance on exit/emergency lights • Investigate Fire Department Connection (FDC) fail 2. Lifecycle <ul style="list-style-type: none"> • Fan coil unit - FCU-1 renewal 3. Deficiency <ul style="list-style-type: none"> • Clean/repair unit heaters • Divert drainage under reading terrace • Provide isolation valves (HHW & CHW) • Repair and caulk all windows • Repair and repaint walls • Repair hard lid ceiling • Repair restroom tiles • Repair terrace slab • Replace ceiling tiles where needed • Replace/repair exhaust fans 4. Maintenance <ul style="list-style-type: none"> • Electrical maintenance on disconnect switches • Electrical maintenance on main switchboard • Electrical maintenance on Motor Control Centers (MCC) • Electrical maintenance on panel boards 5. Testing <ul style="list-style-type: none"> • HHW & CHW piping condition

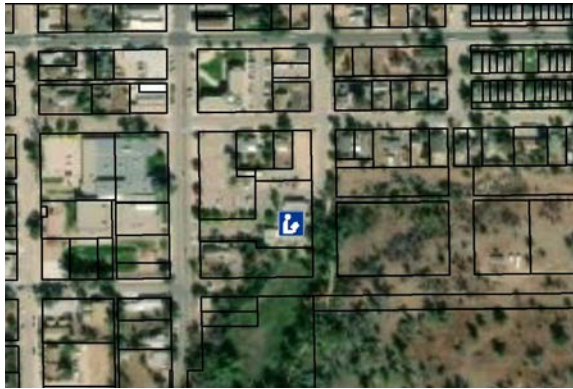
The Fountain Library was constructed and opened in 2006. The library is housed in a 9,582-square-foot facility that Pikes Peak Library District owns.

<p>Key Programmatic Issues</p>	<ul style="list-style-type: none"> • Accessibility concerns, particularly with doors and pavement • Desire for more pods and fewer study rooms • Desire for better outdoor space and improved facility maintenance • More sounds/noise mitigation needed (acoustic panels and treatments)
<p>Key Condition Issues</p>	<ol style="list-style-type: none"> 1. Deficiency <ul style="list-style-type: none"> • Adjust door, frame, and closer • Caulk foundation joint • Investigate slab settlement • Mitigate flange rust and spalling • Repair crack in gyp board • Replace damaged tile • Replace eroding scupper • Replace missing strainer • Route water away from the foundation 2. Maintenance <ul style="list-style-type: none"> • Perform disconnect maintenance • Perform panel board maintenance 3. Testing <ul style="list-style-type: none"> • Investigate temperature differences

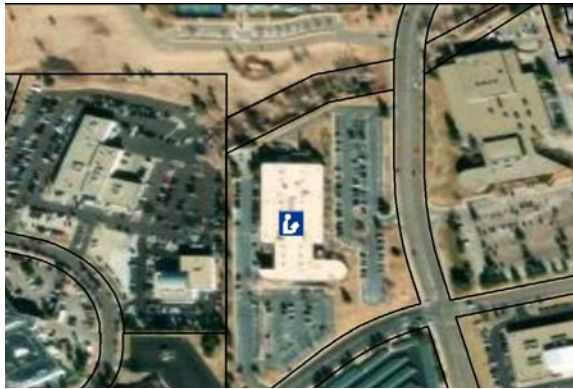
Library 21C was opened in 2014. The library is housed in a 115,058-square-foot facility that was built in 1985 and is owned by Pikes Peak Library District.

<p>Key Programmatic Issues</p>	<ul style="list-style-type: none"> • Break room location is far from staff work location • Staff do not have enough private spaces for their breaks • Checkout desks are too small • Patron flow is confusing • Community rooms are not set up for power outlets • Need for better signage/wayfinding
<p>Key Condition Issues</p>	<ol style="list-style-type: none"> 1. Safety <ul style="list-style-type: none"> • Spare circuit breakers turned off 2. Deficiency <ul style="list-style-type: none"> • Caulk storefront glass • Domestic hot water (DHW) piping modifications • Investigate and repair ceiling below balcony • Investigate return air issue • Repair and repaint walls • Repair backflow preventer • Repair balcony rooftop • Repair condenser fins • Repair EPD at joints • Repair exterior brick veneer • Repair facade at skylight • Repair interior doors • Repair roof flashing • Replace ceiling tiles

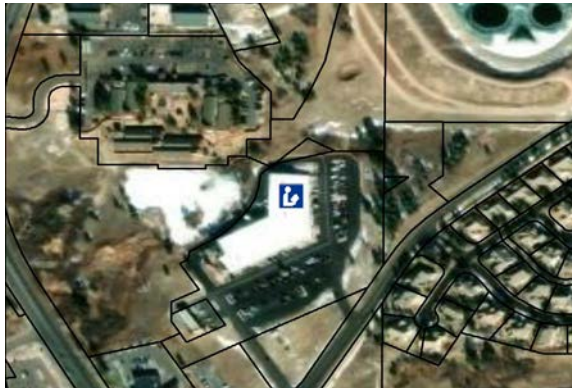
Originally opened in 1975, the Monument Library relocated to a larger space in 1999. It now occupies a 7,536-square-foot facility that is leased to Pikes Peak Library District.

Key Programmatic Issues	<ul style="list-style-type: none"> • Desire for computers to be in a more private area • Desire for more study/community rooms • Staff space is too small • Desire for increased security in staff spaces • The facility is too small for the population it serves
Key Condition Issues	<ol style="list-style-type: none"> 1. Deficiency <ul style="list-style-type: none"> • Relocate thermostat • Replace/repair interior doors • Replace vinyl flooring

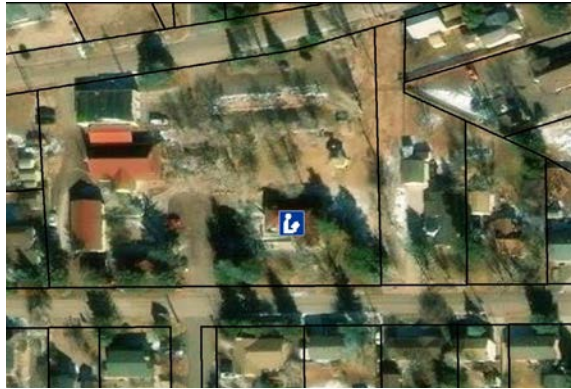
The Palmer Lake Library was officially opened in 1964, at the same time that Pikes Peak Regional Library District was established. The library moved to its current location in 1985. The district leases its facility, built in 1982, from the Town of Palmer Lake.

<p>Key Programmatic Issues</p>	<ul style="list-style-type: none"> • Lack of space for programs • The IT space is insufficient • Insufficient staff space • No program, meeting, or study space
<p>Key Condition Issues</p>	<ol style="list-style-type: none"> 1. Deficiency <ul style="list-style-type: none"> • Repair baseboard finishes 2. ADA <ul style="list-style-type: none"> • Unisex restroom ADA compliance

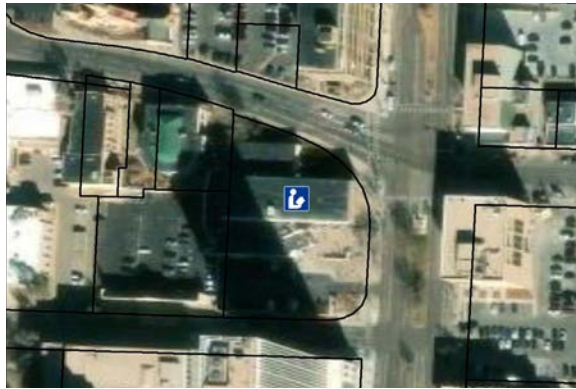
Penrose and Carnegie Library, opened in 1968, is a 78,831-square-foot facility with sections built in 1905 and 1968. It underwent extensive renovation from 1995 to 1999 and is owned by Pikes Peak Library District.

Key Programmatic Issues	<ul style="list-style-type: none"> • Reconfigure teen area • Add more overflow shelving • Expand outdoor staff space/staff room • Enhance security • Address institutional feel of the library • Upgrade climate control/HVAC for Carnegie genealogy/local history building
Key Condition Issues	<p>1. Safety</p> <ul style="list-style-type: none"> • Install cover on meter sockets • Replace tritium exit signs • Deficiency • Investigate AHU-6 lack heat • Investigate and repair fire riser leak • Investigate cause of transformer noise • Investigate cause of water leak • Investigate fan running in manual mode • Replace damaged overhead garage door • Replace garage slab • Replace recirculating pump • Replace water meter • Reseal joint between wall panels • Attach meter to wall • Repair upper-level lighting • Replace damaged ceiling tile <p>2. Maintenance</p> <ul style="list-style-type: none"> • Perform maintenance on panels • Codes and standards • Install railing along loading dock • Provide electrical clearances per code • Perform maintenance on panels • Recondition inoperable Cabinet Unit Heater (CUH)

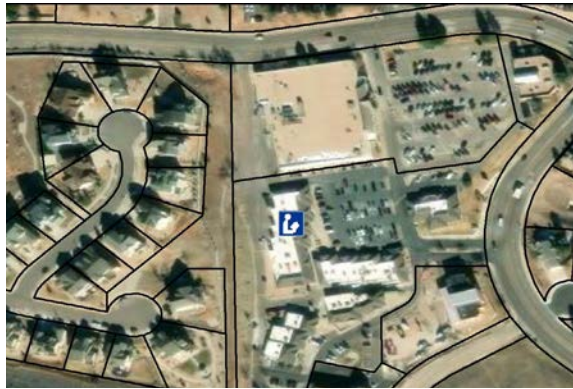
The Rockrimmon Library was opened in 1989. The 8,668-square-foot facility has been leased by the Pikes Peak Library District since 1995.

<p>Key Programmatic Issues</p>	<ul style="list-style-type: none"> No ADA entrance No break room for staff Concern about flooding Parking is a big issue Space too small for current usage
<p>Key Condition Issues</p>	<ol style="list-style-type: none"> Lifecycle <ul style="list-style-type: none"> Replace restroom fixtures Deficiency <ul style="list-style-type: none"> ADA improvements - entry Repair drywall Replace carpet - staff area Maintenance <ul style="list-style-type: none"> Repair wall/ceiling Codes and standards Add point of use hot water heater

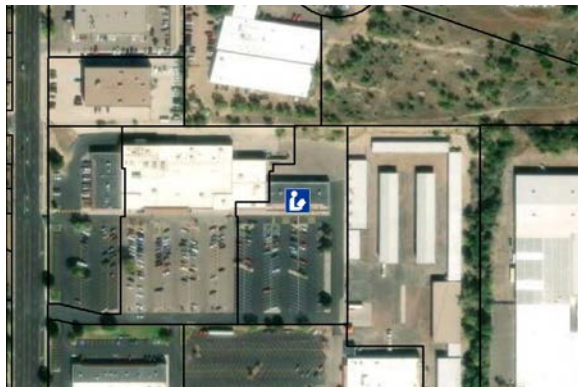
Ruth Holley Library was opened in 1987 and relocated in 2004. The library is housed in a 10,469-square-foot facility that was built in 1978 and is leased to Pikes Peak Library District.

Key Programmatic Issues	<ul style="list-style-type: none"> • Lack of quiet space • Very insufficient staff space • No early literacy space • Inadequate programming space • Temperature zoning/control • Have a hard time storing odd-shaped books
Key Condition Issues	<p>1. Deficiency</p> <ul style="list-style-type: none"> • Install restroom electric heater • Repair tiled baseboard • Replace stained Acoustical Ceiling Tile (ACT) • Seal exterior windows

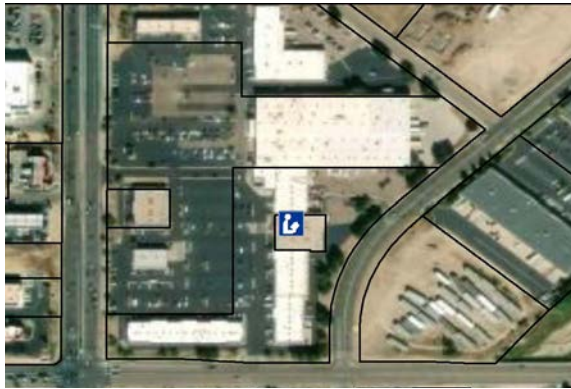
Sand Creek Library was opened in 1988 and relocated to the current space in the same center in 1994, purchased by the Library District. The library is housed in a 14,060-square-foot facility.

<p>Key Programmatic Issues</p>	<ul style="list-style-type: none"> • Lack of quiet space • Insufficient user seating • Insufficient study space • Restrooms have issues • Shelf space is undersized • Desire for a better teen space, sensory accommodations, and pumping/breastfeeding rooms • Desire more outdoor space
<p>Key Condition Issues</p>	<ol style="list-style-type: none"> 1. Deficiency <ul style="list-style-type: none"> • Recaulk toilet base • Replace caulking at the foundation • Replace damaged ceiling tiles 2. Maintenance <ul style="list-style-type: none"> • Perform panel board maintenance
